Microstructural Characterization of Thermal Barrier Coatings Glazed by a High Power Laser

Hong Zhou^{1*}, Fei Li², Jun Wang² and Bao-de Sun²

Abstract

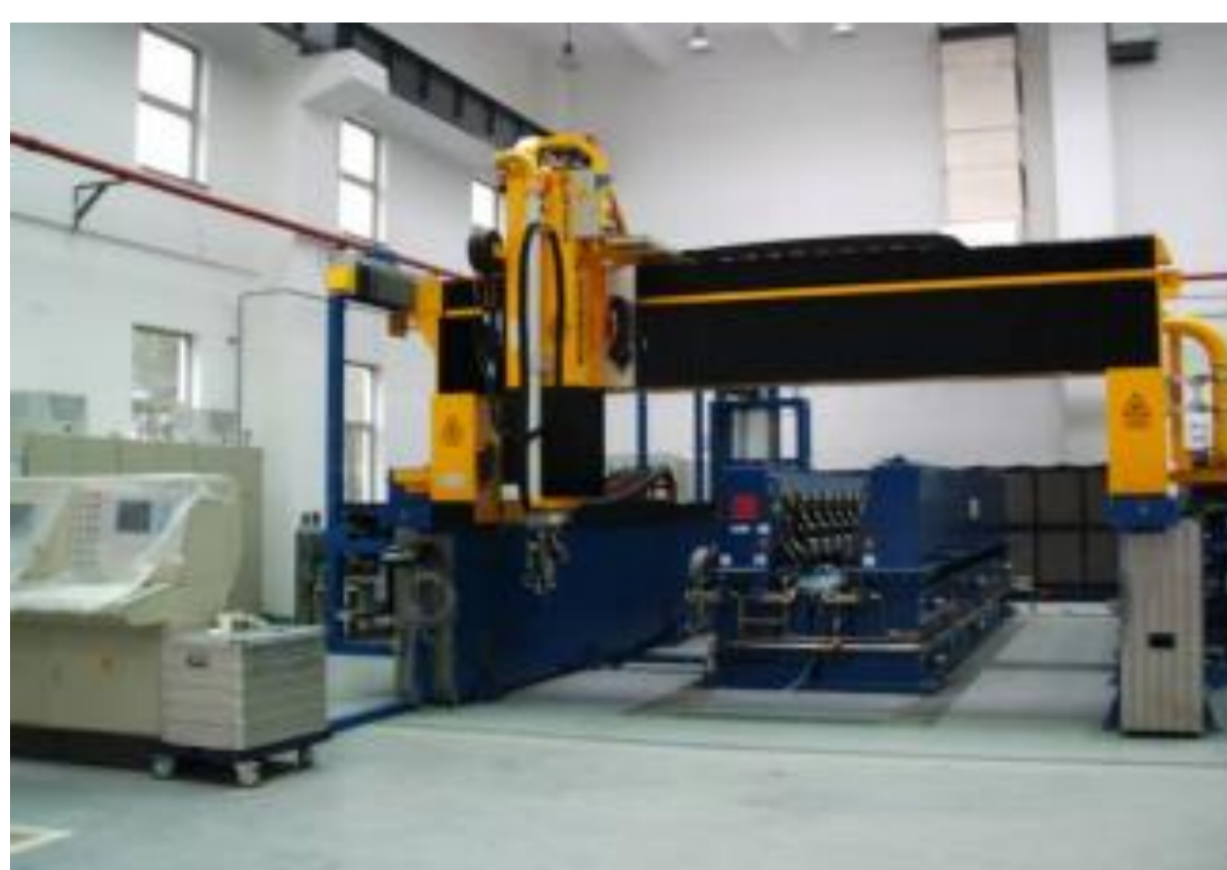
Fig. 1 The industrial CO₂ continuous wave laser

Laser processing. The Laser-glazing process was carried out on the plasma-sprayed TBC surface by using an industrial high power (maximum output power of 15 kW) CO₂ continuous wave laser (TLF15000, Trumph Laserzell, Germany) at a power of 3,500 W, as shown in figure 1. The laser system characteristics and processing parameters are listed in table 2.

Wave type:	Continuous
Wave length (μm):	10.6
Raw beam size (mm):	25
Focal length (mm):	357
Focal point diameter (mm):	0.7
Defocus distance (mm):	120
Glazing beam diameter (mm):	8.4
Power (W):	3,500
Scanning speed (mm/min):	10000
